John Hill Construction, LLC  
123 S. Second St., Loveland, OH 45140

**RESIDENCE**

202 Railroad Ave., Loveland, OH 45140

This inspection report is intended to detail the condition of the structure and mechanical systems in relation to the feasibility of this house being restored to a habitable domicile that is current with modern building codes.

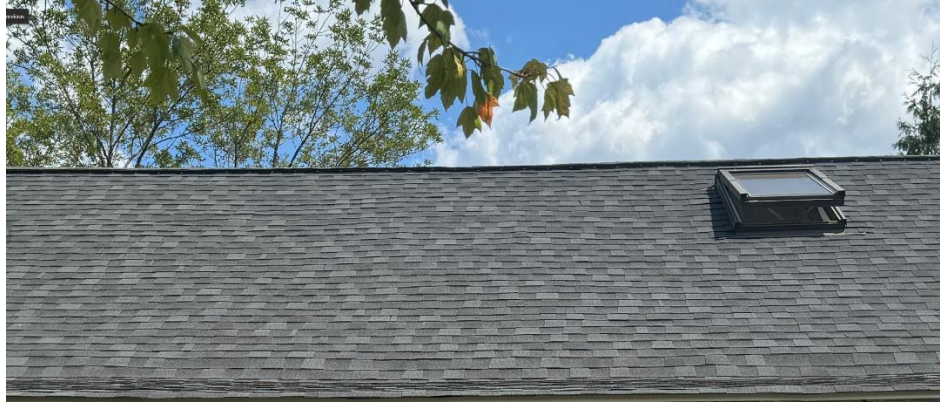
- 1) The roof surface is composed of two layers of asphalt shingles, indicating the top layer has been added onto the older layer. This should be remedied as it **causes excess moisture to be trapped against the sheathing.**
- 2) Waviness in the roof line indicates **failing roof sheathing** that needs to be replaced.

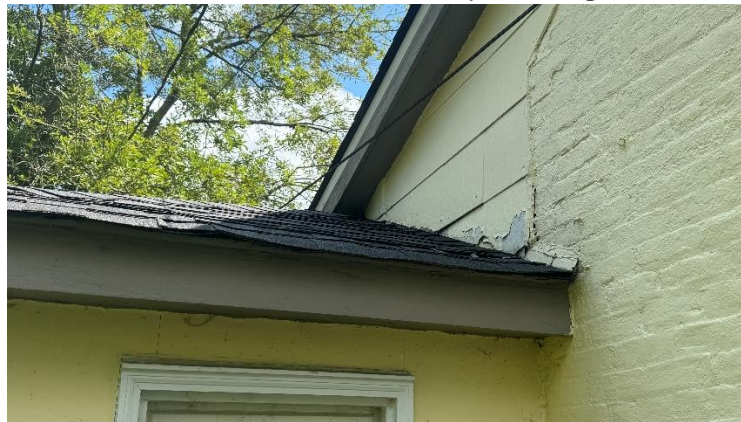
- 3) The house is **missing gutters** on over 75% of the eaves. The lone gutter that is present is failing. All new gutters are required to be professionally installed.
- 4) Siding rot indicates **the roof flashing is installed improperly.** The flashing requires replacement. This includes around the boots for plumbing vents.

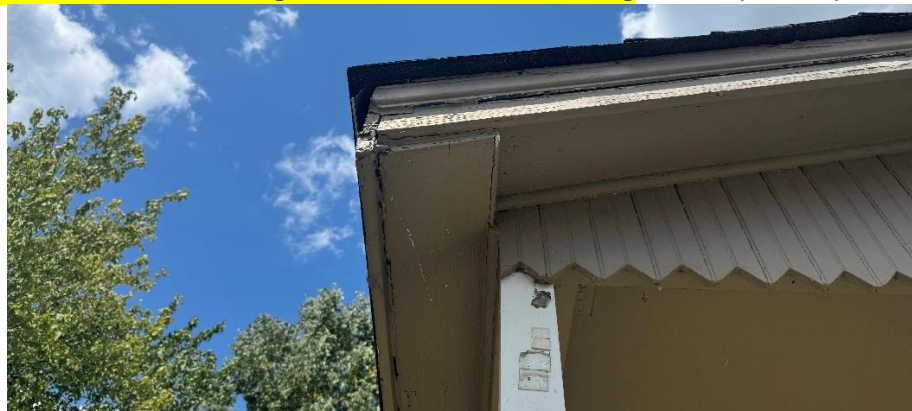
- 5) The **soffits, rake boards and gutter boards are all failing** and require replacement.

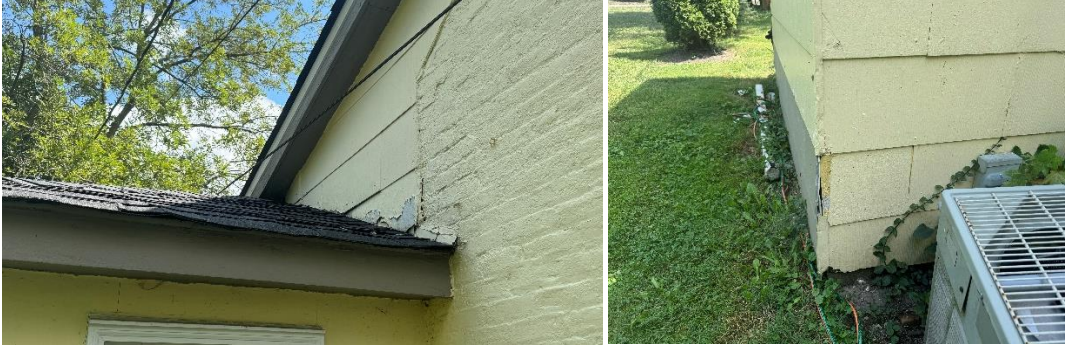
- 6) The siding is a combination of **asbestos paneling** and T-11 plywood. It is failing in multiple areas, and needs to be replaced with a modern equivalent material. **Asbestos remediation is required**. Wall sheathing is rotten as well. Sheathing requires replacement.

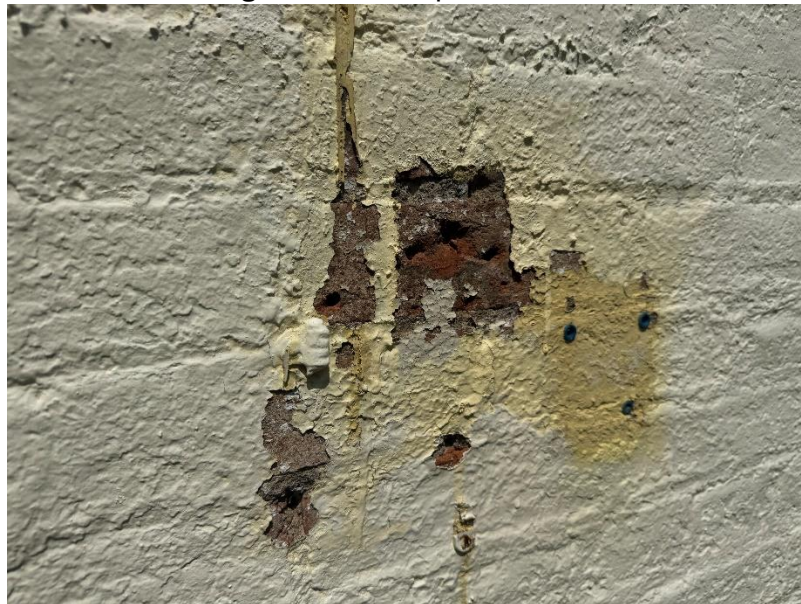
- 7) The paint on the **brick is failing and chipping**. Additionally, the brick shows signs of **efflorescence and mortar failure**. The paint needs to be stripped, the brick acid-washed and the areas of failing mortar tuck-pointed.

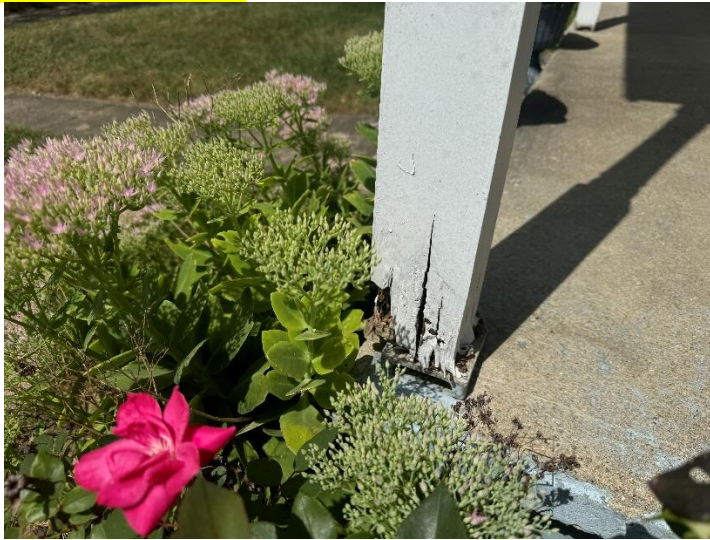
8) The porch columns are rotted out and pose an immediate threat of collapse.

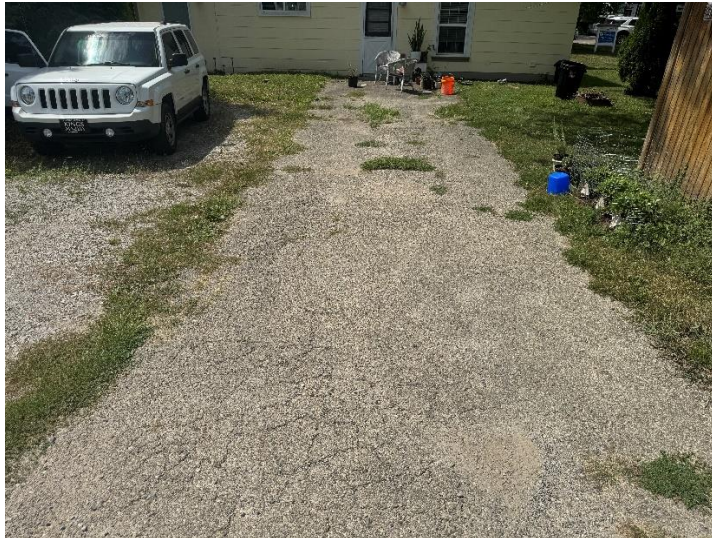
9) The blacktop driveway is deteriorated to a point of posing a tripping hazard, and is too dilapidated to warrant re-topping. The blacktop requires tear out and replacement.

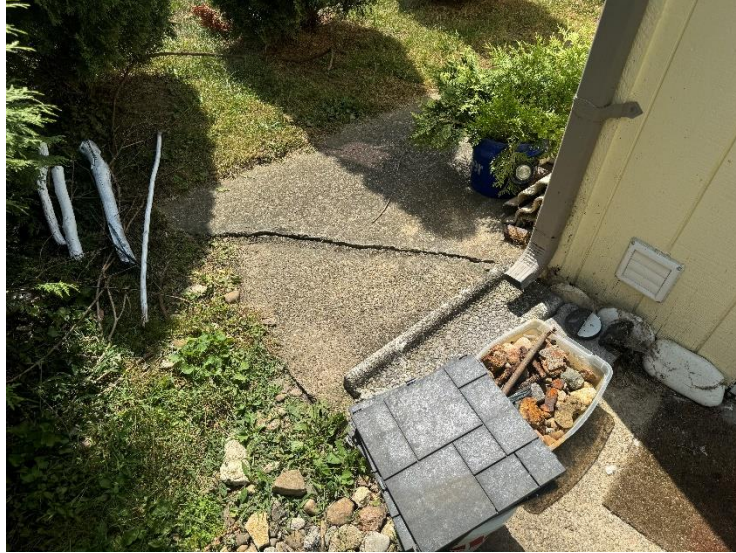
- 10) The sidewalk on the right and rear of home is **cracked and sunken in multiple areas, posing tripping hazards.** Sidewalk requires tear out and replacement.

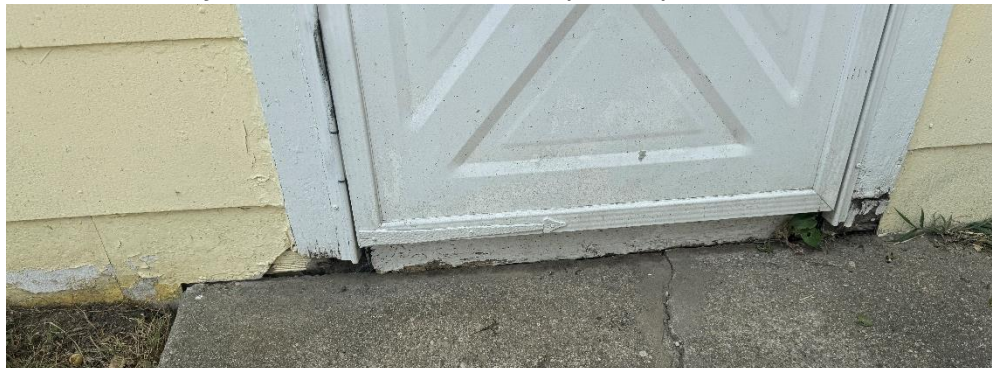
- 11) The **thresholds for the custom rear doors are rotted** and causing the entire door system to fail. The doors require replacement.

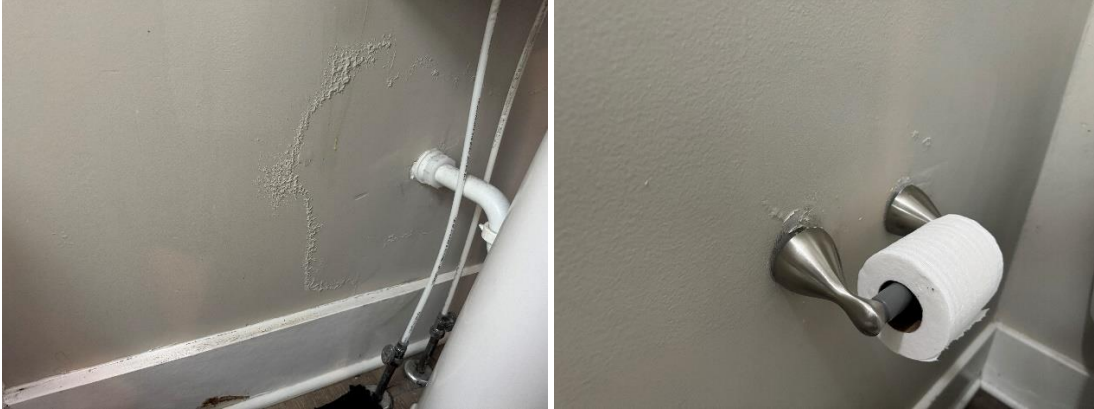
- 1) Multiple interior walls show evidence of water intrusion and damage. Drywall requires replacement in multiple areas.

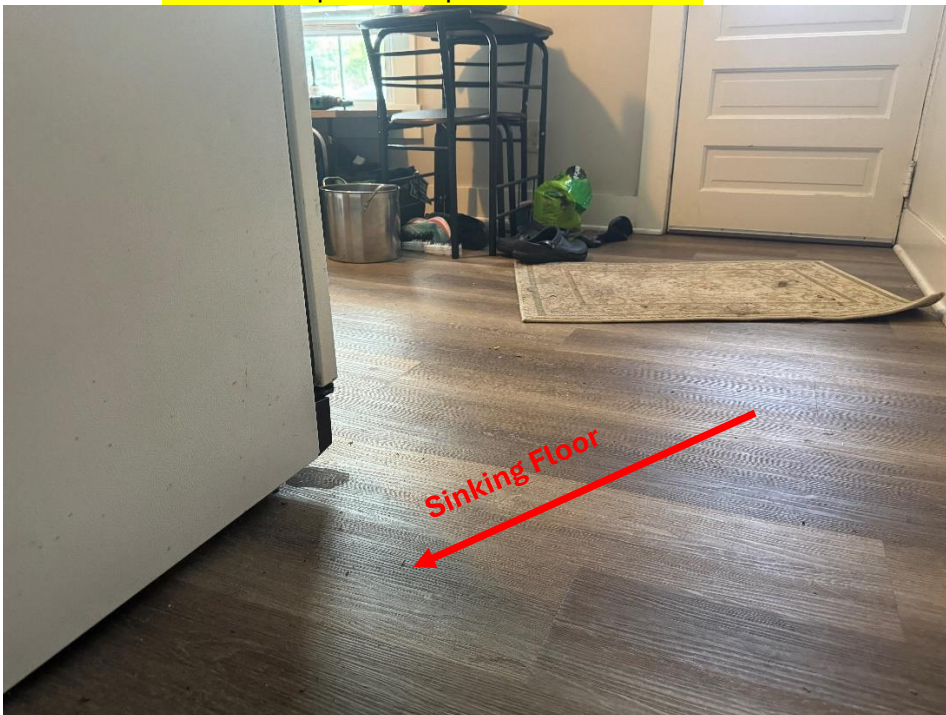
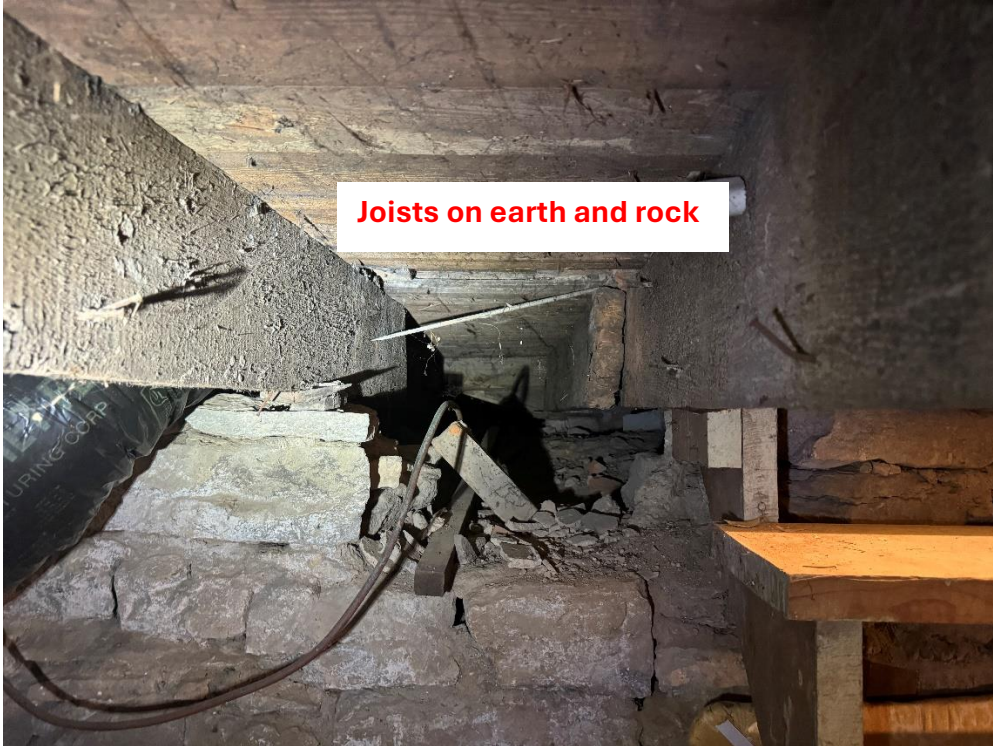
- 2) Floors in both kitchens are sinking, indicating failing structural members beneath. This portion of the building is constructed by laying joists on rocks. There is no proper crawl space. Whole floor requires demolition and installation of proper foundation. This will require complete new kitchens.

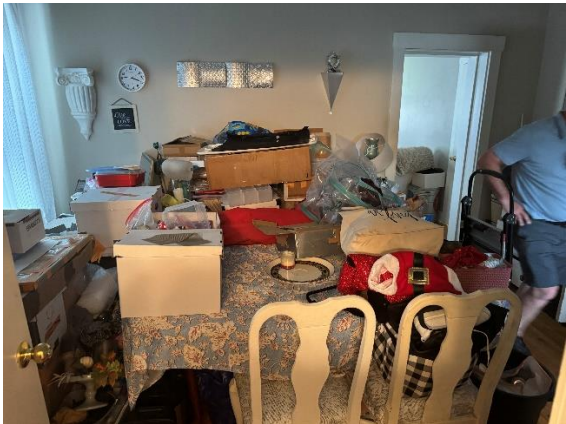
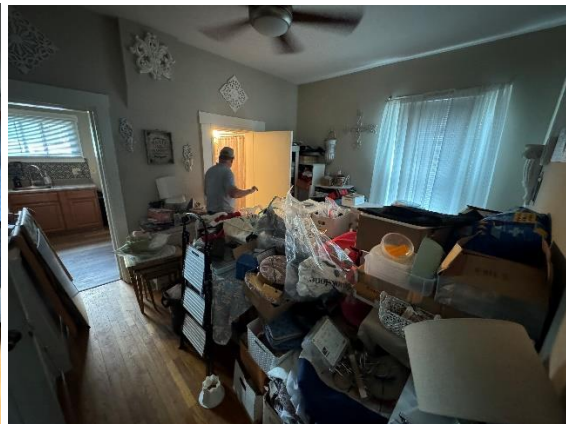
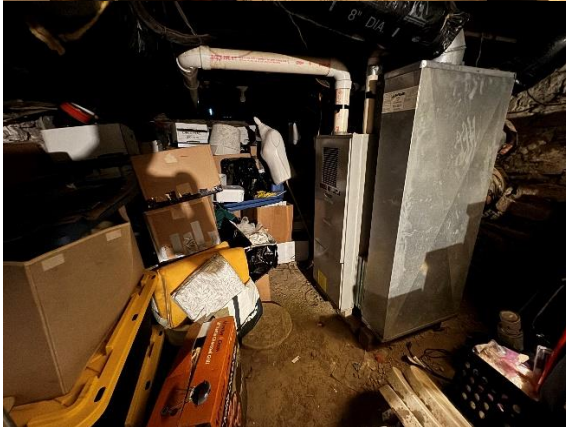
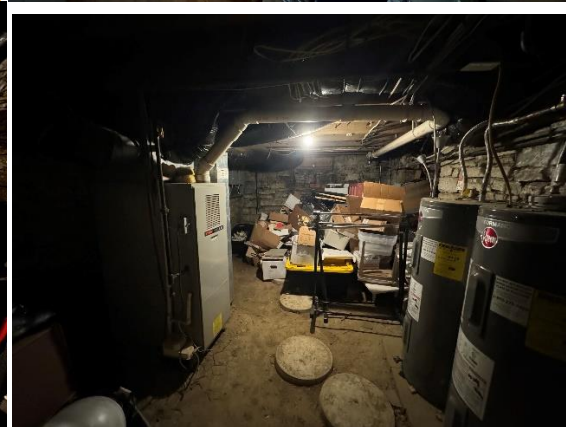
3) Junk removal and disposal services required to rid debris left by former tenant.

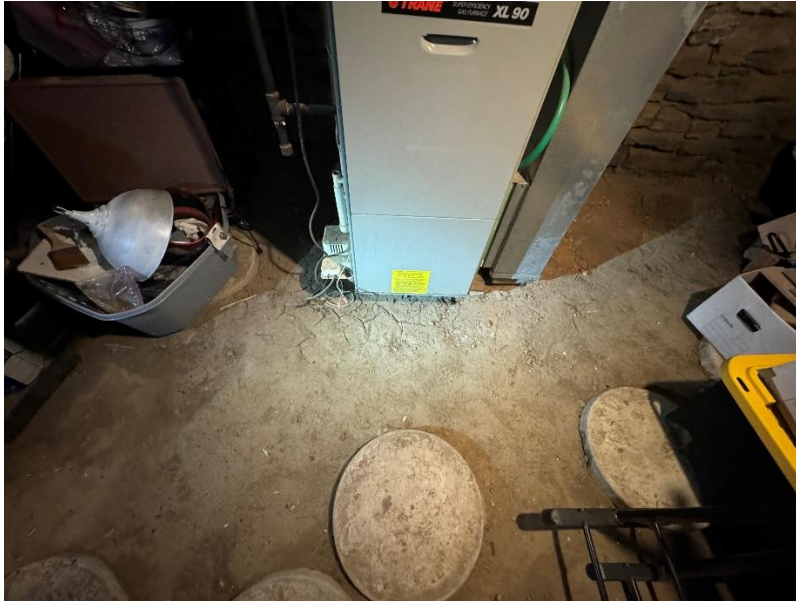
- 4) Basement floor consists of dirt, holding moisture and presenting a health hazard. Floor required to be hand-poured to convert to concrete.

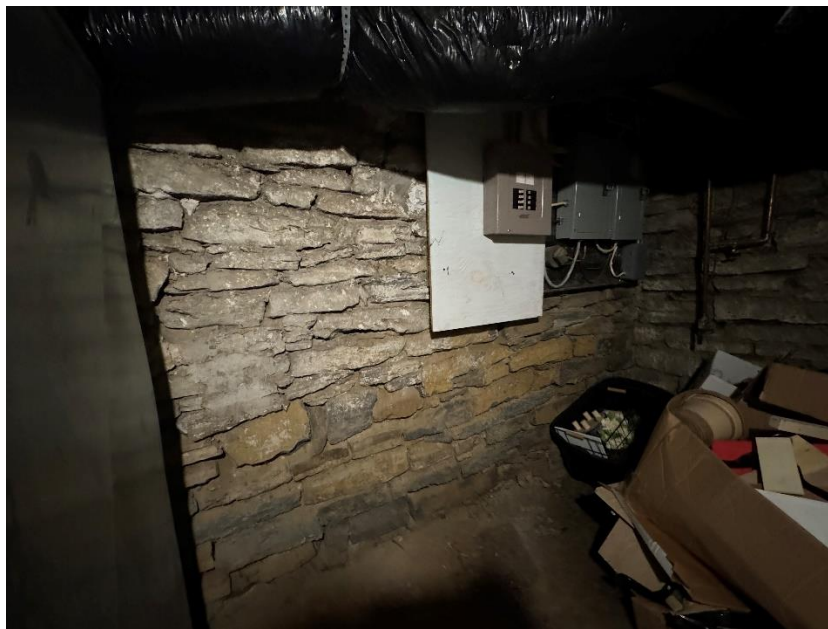
- 5) Foundation walls (in areas that have foundation) are stone, permitting water intrusion. French drain system is required to be installed and tied into city storm water system.

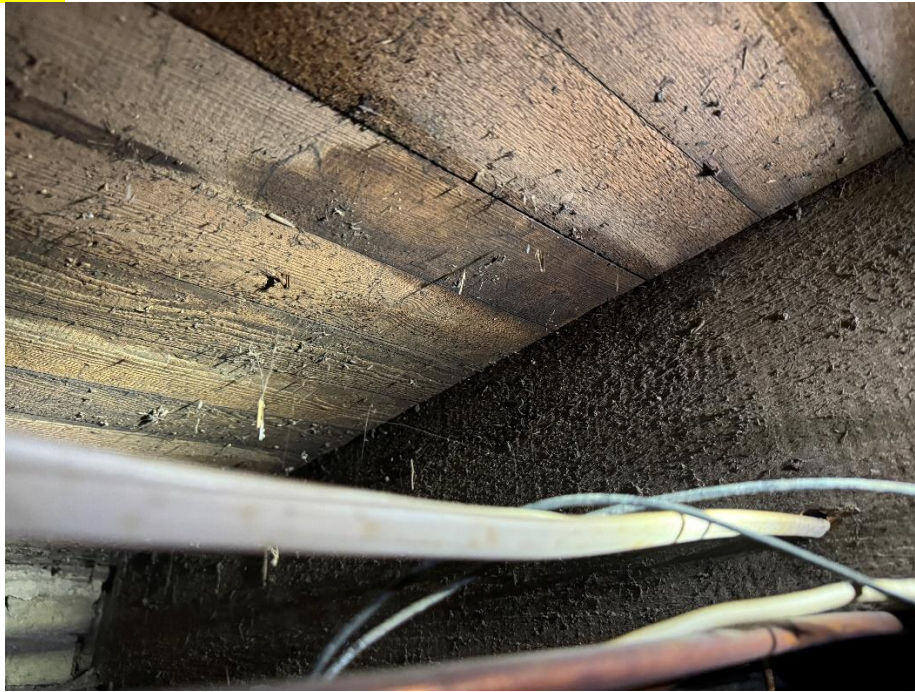
- 1) **Wet subfloor** below bathroom. Plumbing repair required.

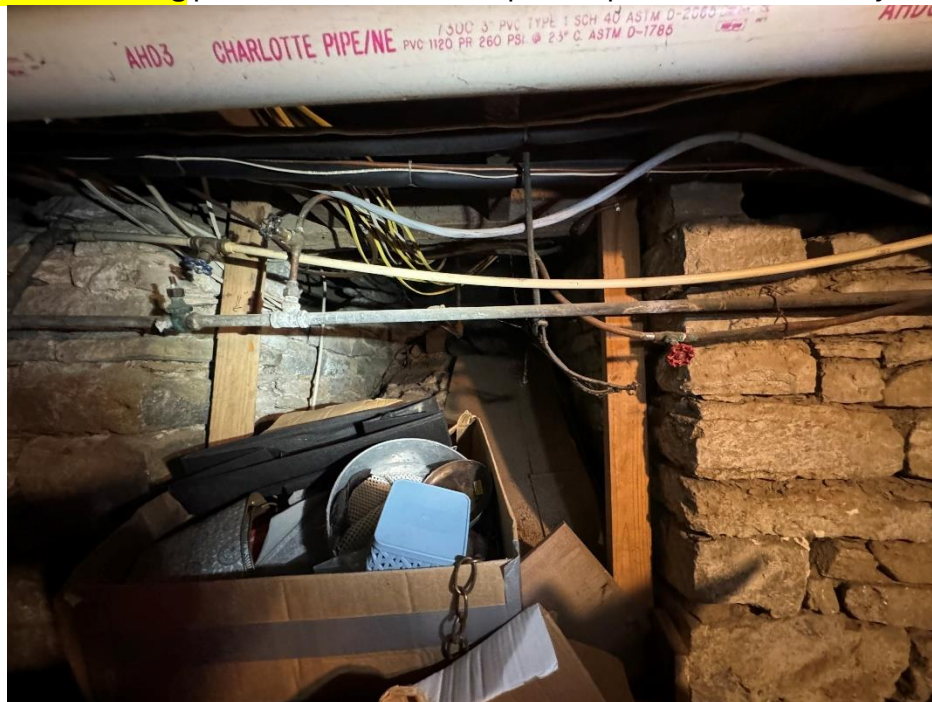
- 2) **Knob and tube wiring** present and in use. Requires updated to modern system.
